**Evaluation of Road Decommissioning,
CDFG Fisheries Restoration Grant Program,
1998 to 2003**

**The California Department of Fish and Game
Contract #P0210559**

**Pacific Watershed Associates
P.O. Box 4433, Arcata, California
707-839-5130**

July, 2005

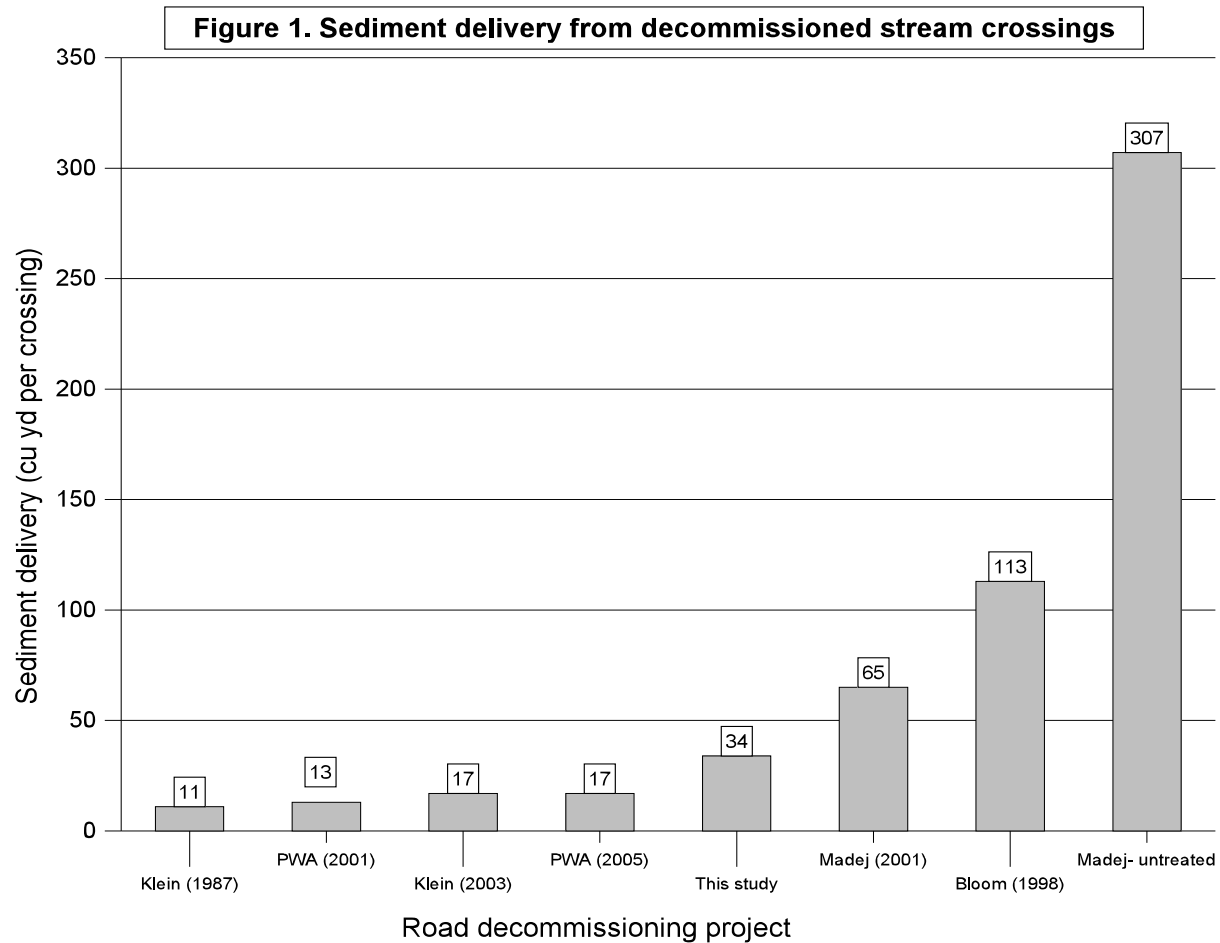
Figure 1 depicts the post-decommissioning stream crossing erosion measurements that have been developed for sites within several Northern California watersheds, including volume estimates from decommissioned stream crossings from the current regional study (PWA, this study). PWA (2001, unpublished) sampled 20 excavated stream crossings in the Rowdy Creek watershed following the first full winter season and identified both channel erosion and mass wasting as important sediment delivery processes (Figure 1). Similarly, preliminary data is also included from a study of road decommissioning in the Elk River watershed (PWA, 2005). In that study, sediment delivery from 86 decommissioned sites, including 52 stream crossings, averaged 11 yds³/site, with stream crossings generating an average of 17 yds³/crossing (Figure 1).

The variability of post-treatment erosion and sediment delivery is sometimes large. Thus, although some post-decommissioning erosion and sediment delivery occurs at virtually all excavated stream crossings, most sites typically exhibit very little erosion (Klein, 2003). Often a few of the treated sites (especially excavated stream crossings) often generate the bulk of the eroded sediment (Madej, 2001; Klein, 2003; PWA, 2005). Likewise, in the current study, we have also found a substantial range in regional erosion and sediment delivery volumes following road decommissioning, some of which can be attributed to uncontrollable site variables (such as geologic substrate and soils) and some of which is the result of implementation practices (Figure 1).

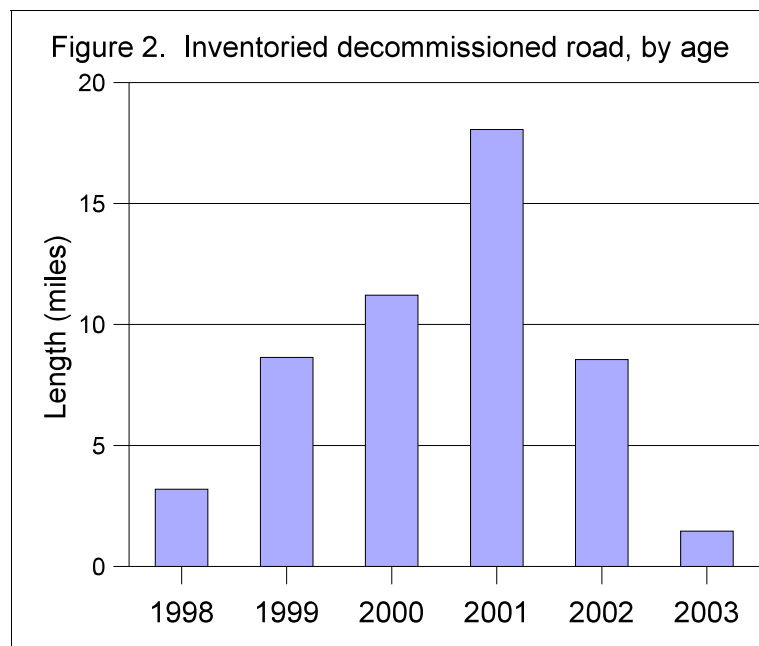
The age of decommissioning for each road included in the assessment was determined from final contract reports submitted to CDFG after the completion of road decommissioning. The age of road decommissioning ranged from 1998 to 2003. Specifically, we evaluated approximately 3.19 miles (6%) of road decommissioned in 1998, 8.64 miles (17%) in 1999, 11.21 miles (22%) in 2000, 18.06 miles (35%) in 2001, 8.55 miles (17%) in 2002 and 1.46 miles (3%) in 2003 (Table 2; Figure 2).

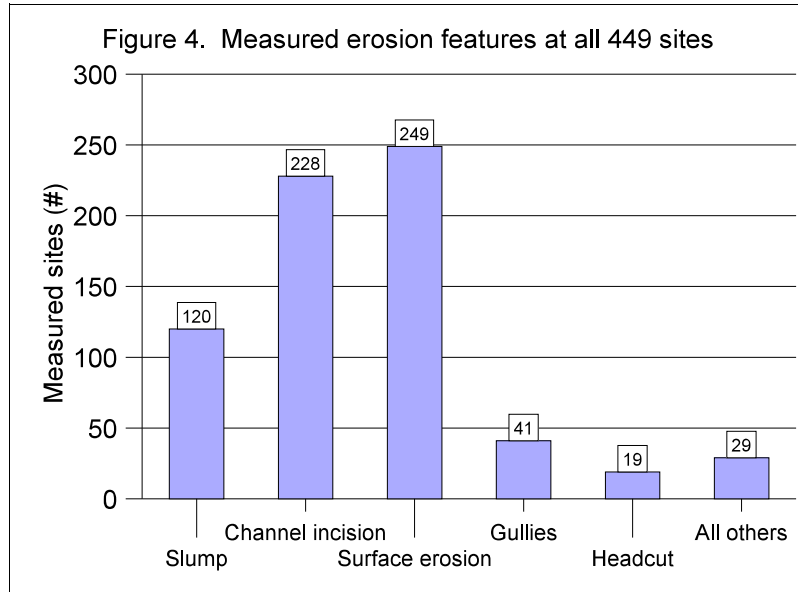
Estimates of post-decommissioning erosion and sediment delivery at each inventoried site were delineated by erosion feature type (Figure 4). Erosion features identified at treated sites included bank erosion, channel incision, gully, headcut, surface erosion, rills, slumps, and “other” (Tables 3a-c). Each treated site type may have exhibited one or more erosion feature types. For example, an individual excavated stream crossing may have displayed a number of these erosion feature types, each of which contributed to sediment delivery at the site. All of the categorized erosion types were found at stream crossing sites. Slumps/landslides, gullies and rills, and surface erosion were identified at landslide sites. Gullies and rills, headcuts, slumps, and surface erosion were identified at “other” sites.
